**THEORY, DEVELOPMENT, AND TEST  
OF A CRASH FIRE-INERTING SYSTEM  
FOR RECIPROCATING ENGINE HELICOPTERS**

**December 1963**

TRECOM Technical Report 63-49

AVIATION SAFETY ENGINEERING AND RESEARCH

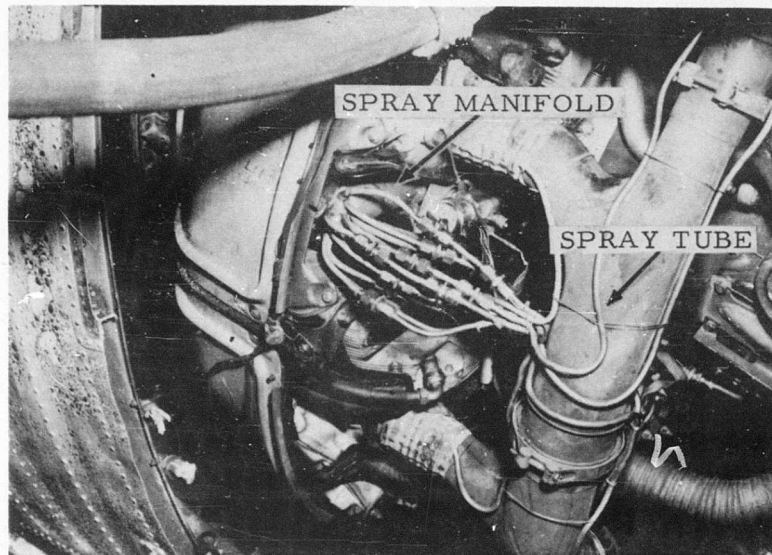
Figure 1A. Spray Distribution Tube Layout  
With the shroud removed, the spray tube layout and spray manifold are visible on the actual test aircraft (postcrash photo).

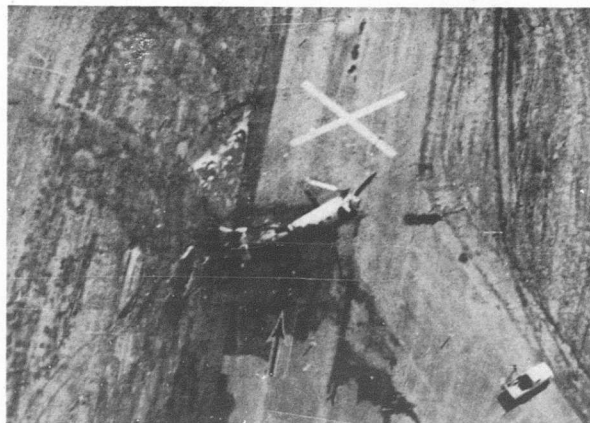
Figure 18. Postcrash View.

This photograph illustrates the final resting position of the helicopter. The forward portion of the helicopter is yawed approximately 45 degrees from the line of flight (arrow) and the aft section is yawed an additional 15 degrees.

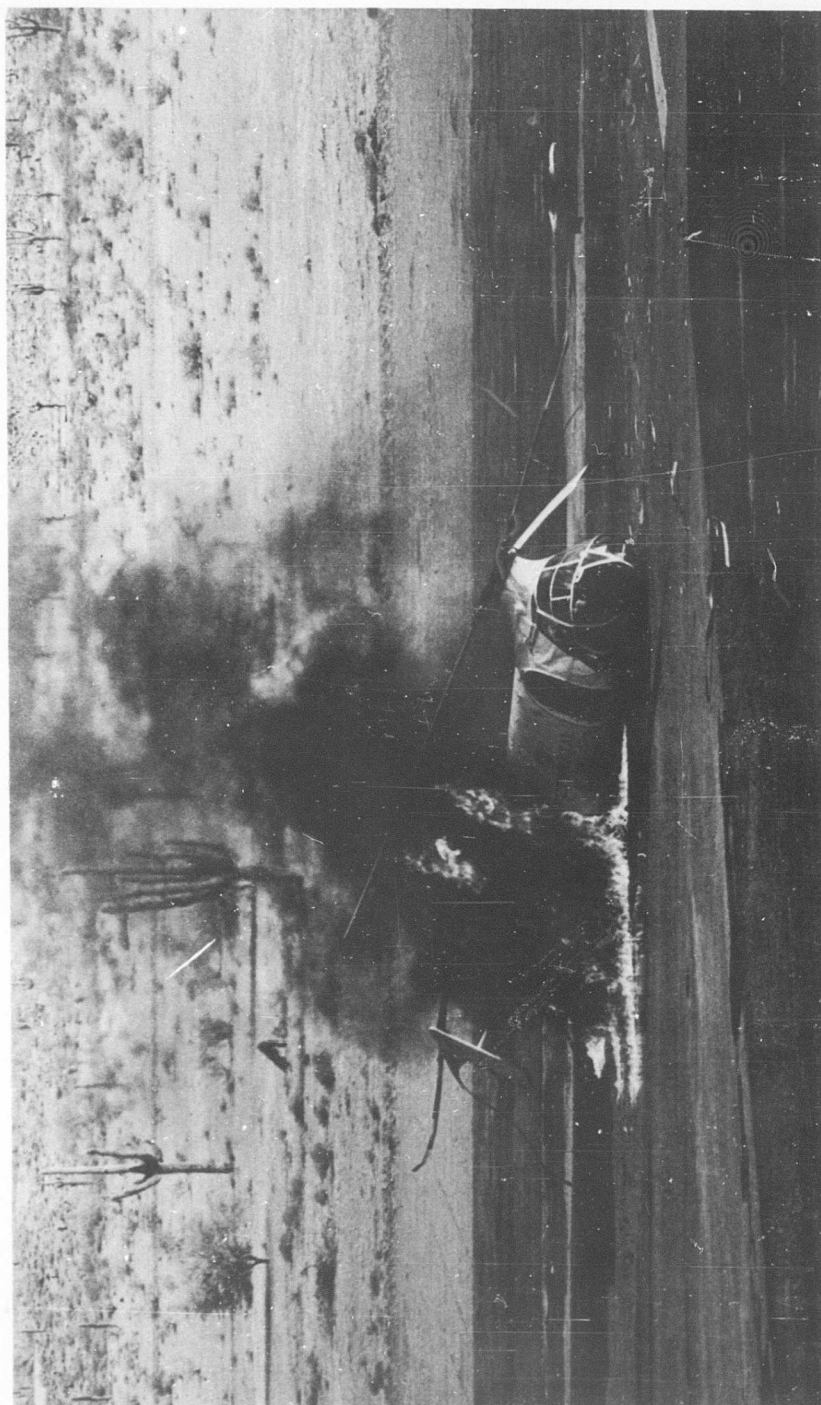
Figure 25G. In this photograph the aircraft has come to rest, and the flash fire is beginning to die down.  
Time: + 60.0 Seconds

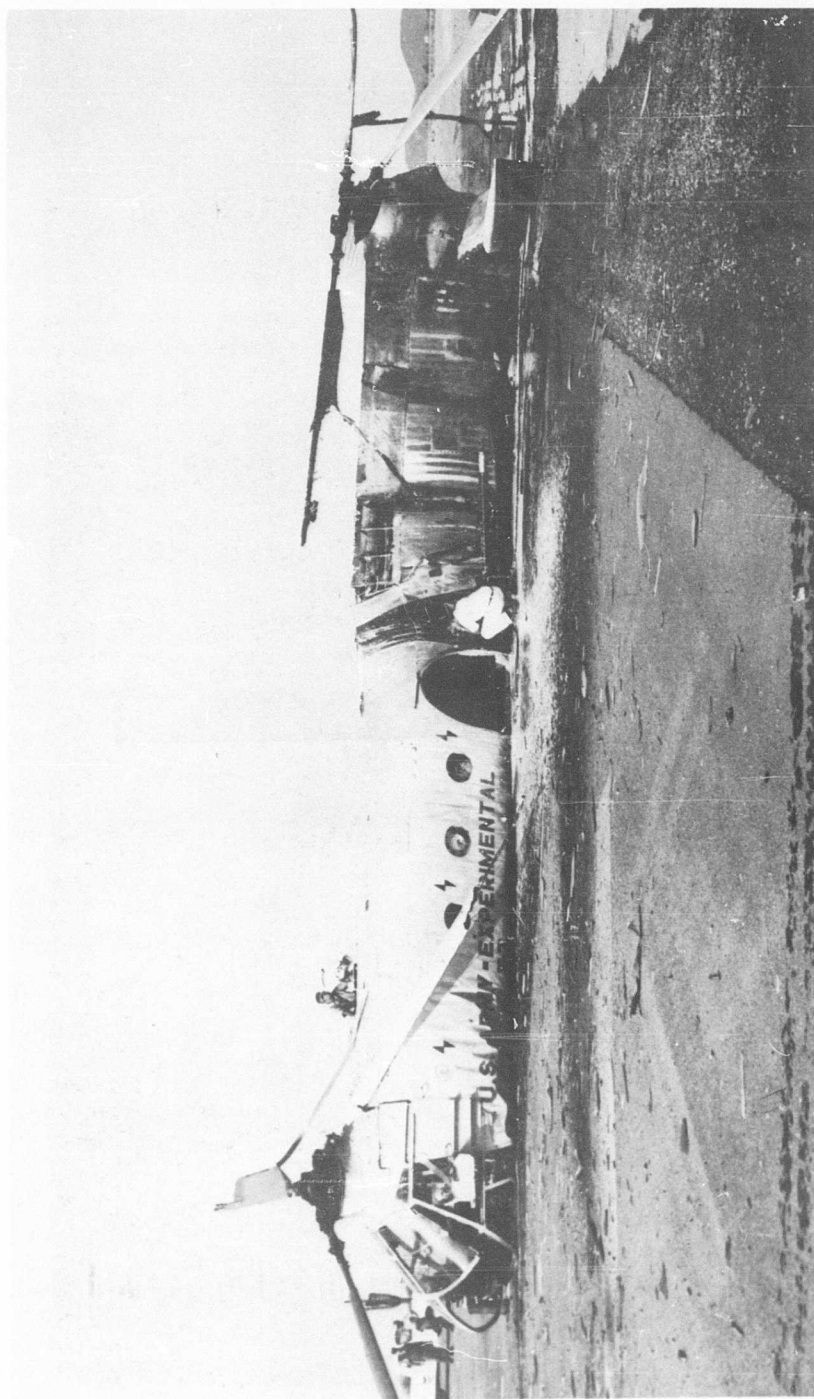
Figure 25H. Postcrash View.

As the aircraft struck the ground and skidded forward, it yawed to the right and came to rest at approximately 45 degrees from the line of flight and in the upright position as shown in Figure 18. The sequence of photographs (Figure 25) presented in Appendix III illustrates the kinematic behavior of the aircraft during the first 3 seconds following impact. At 1.46 seconds after nose-wheel impact, a fire involving the 3-1/2 gallons of aviation gasoline in the main fuel tank appeared. The possible ignition sources are discussed in the following section.
